Manhole Inspection Summary

Manhole # S15AA1015MH

Location Address: **3700 REISTERSTOWN RD**

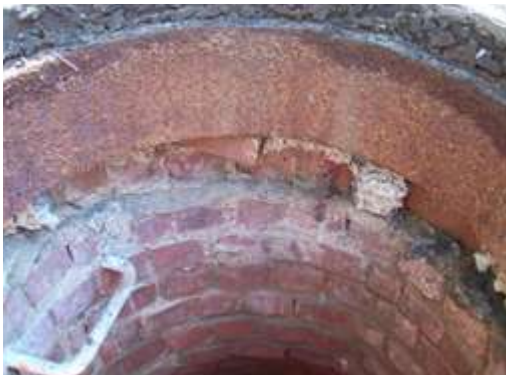
Defect 4

Condition: ☐ Sound ☐ Cracked ☐ Root Intrusion ☒ **Loose Brick** ☐ Deteriorated

LOOSE BRICKS

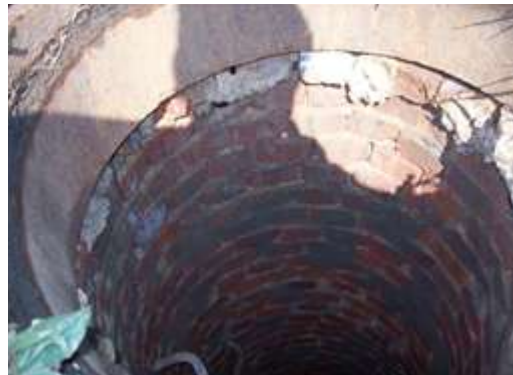
Defect 1

Condition: ☐ Sound ☐ Cracked ☐ Root Intrusion ☐ Loose Brick ☒ **Deteriorated**

CHIMNEY DETERIORATED

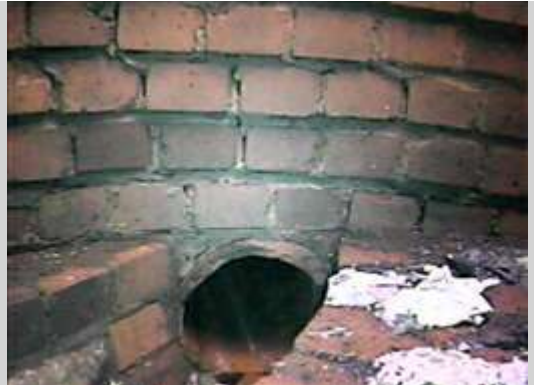
12 O'Clock Outflow

Pipe Height: (in.) Direct
Pipe Material: **Clay** ☐ Pipe Lined
Invert Depth: **6.02** (ft.) Flow Characteristics: **None**
Deposits: ☒ None ☐ Mud ☐ Sludge ☐ Debris ☐ Grease
Silt Depth: (in.) Deposits Extent:
Infiltration: **None** Pipe Seal Cond: **Sound**

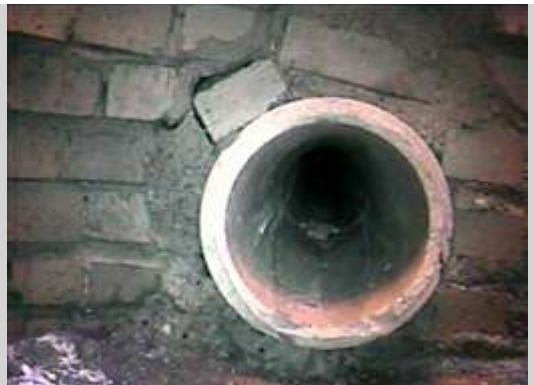
3 O'Clock Inflow

Pipe Height: (in.) Direct
Pipe Material: **Clay** ☐ Pipe Lined
Invert Depth: **5.05** (ft.) Flow Characteristics: **None**
Deposits: ☒ None ☐ Mud ☐ Sludge ☐ Debris ☐ Grease
Silt Depth: (in.) Deposits Extent:
Infiltration: **None** Pipe Seal Cond: **Sound**

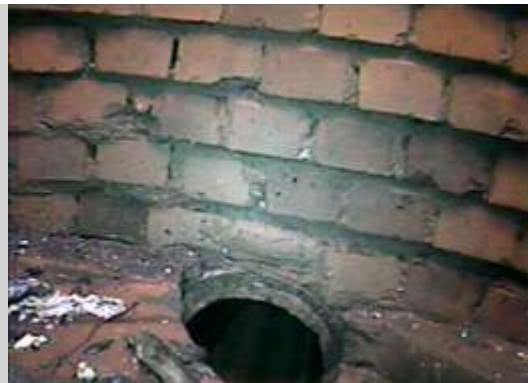
9 O'Clock Inflow

Infiltration: **None** Pipe Seal Cond: **Sound**
